2. Observations made during the survey

4. A low cost lightning protection system

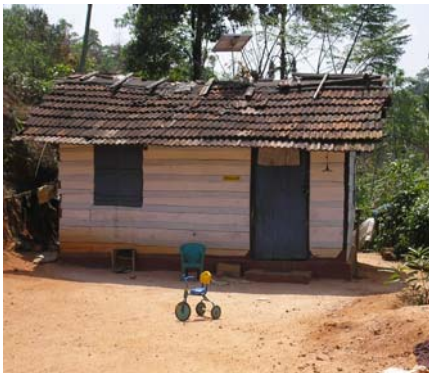
Fig. 2 A house damaged by lightning

During the survey we have inspected more than 55 houses. None of them were equipped with lightning protection devices neither the villagers heard about that such a system can be used to protect their lives and property. Electricity was not available most of the houses and some people were using solar power for their day today needs. The few houses use mains power, the electrical earthing arrangement was not done properly. Some villagers do not realize the importance of the earth rod and they just ignore it .It was noticed that most of the damages in this village was due to direct lightning or side flash.

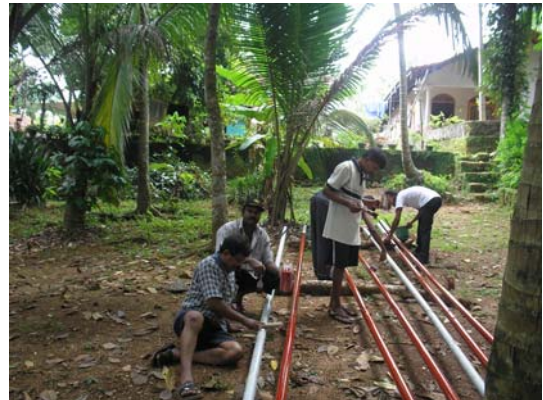
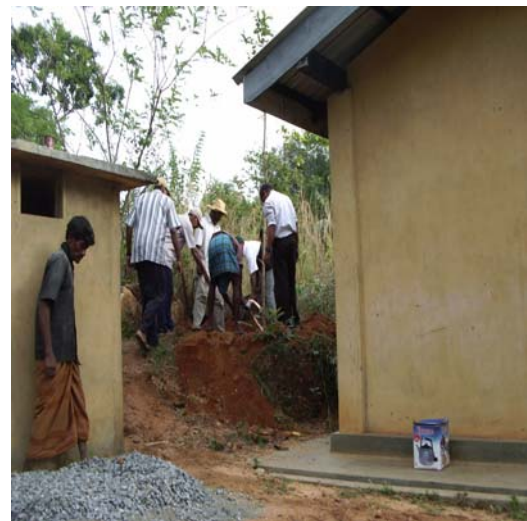
Fig. 7 Installation of lightning protection towers

Out of 27 lightning protection towers installed in the entire village, earthing arrangement of the 3 towers was done with coco peat and another three towers were done with paddy dust or rice hulls. *Bentonite* was used for the rest of the towers.
