Investigating floor moisture problems

Using Automated Long-Term Monitoring of Relative Humidity

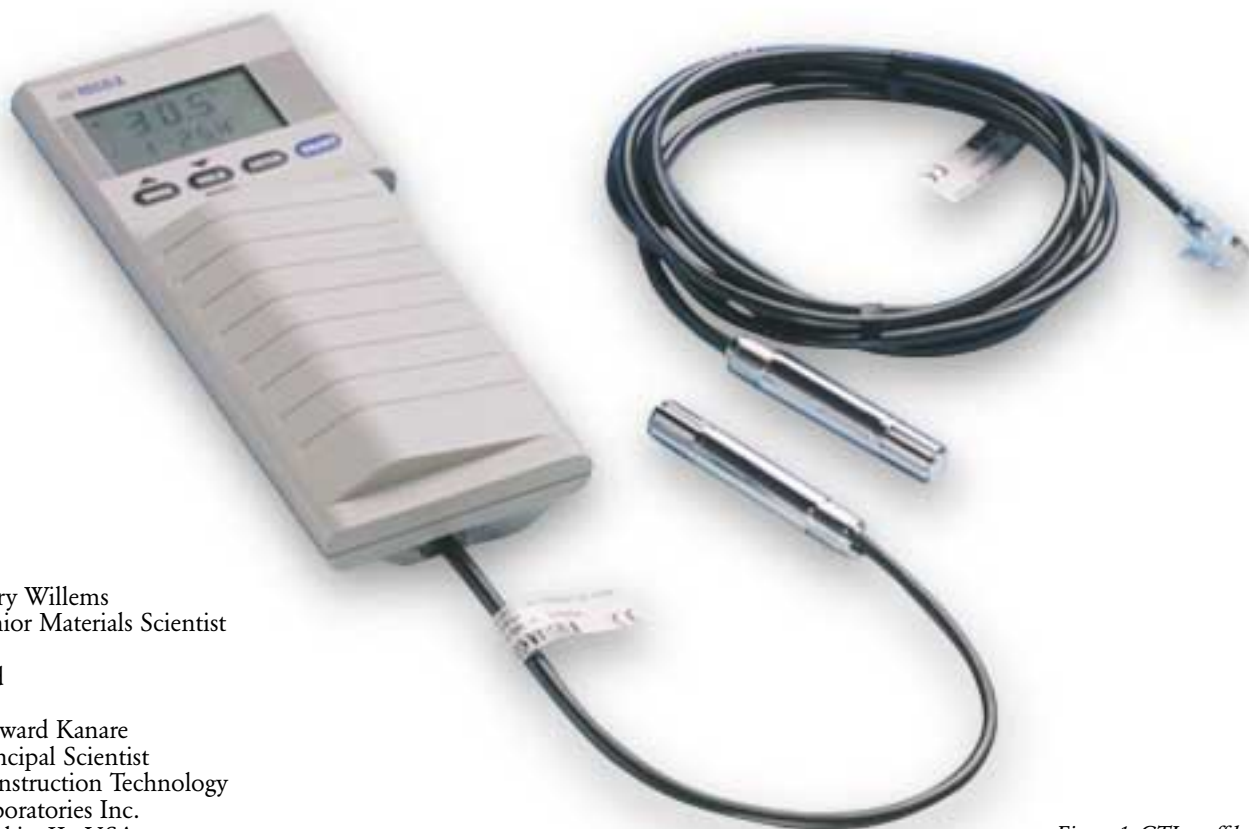
Figure 1. CTL staff have been using Vaisala's HMI41 hand-held moisture meters and HMP44 measurement probes for relative humidity measurement in concrete slabs.

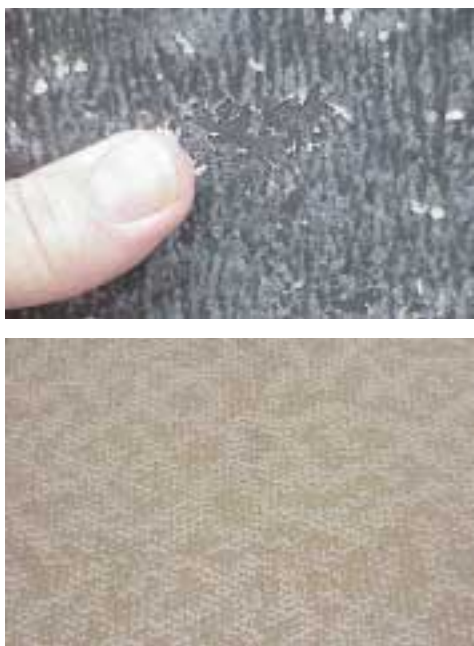
Vinyl-backed carpet tiles had been installed in a medical facility on two concrete substrates: a slab-on-ground and an adjacent elevated lightweight concrete slab cast on ribbed steel deck. Carpet tiles installed on the elevated lightweight concrete were well-bonded and did not exhibit distress. However, carpet tile was curling and debonding on the slab-on-ground. The slab-on-ground consisted of a 5-inch (125-mm) thick, normal weight concrete slab cast on 7-inch (175-mm) sand layer on top of an 8-mil (0.2-mm) plastic vapor retarder. The vapor retarder sheet should have kept moisture from entering the floor system from below, but moisture was somehow getting to the underside of the carpet through the concrete. Vaisala HMP44 relative humidity probes were selected to study the situation.

Figure 4. Carpet tile was curling and debonding on the slab-on-ground.

mended to the facility owner that the existing flooring should be replaced with less-moisture-sensitive flooring.

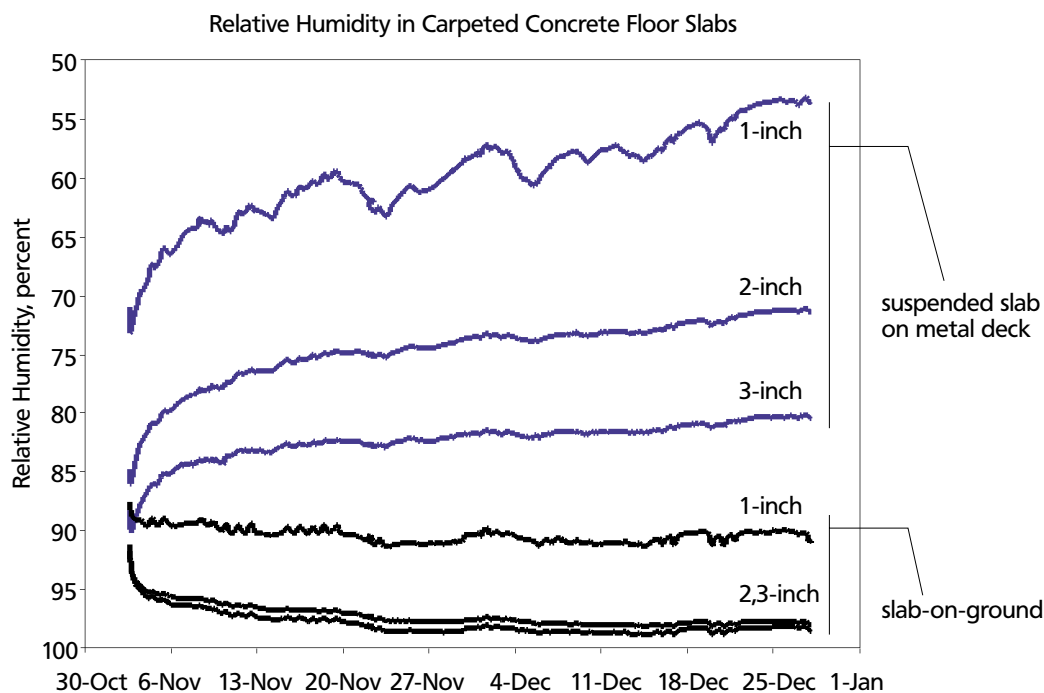
Two useful results came from the data collected over two months. First, the results (see Figure 5) indicated that in the area of distressed carpet on the slab-on-ground, moisture levels were very high, averaging about 97 % RH at two-inches (50 mm) below the top of the slab.

By contrast, the elevated slab had 70–75 % RH at the same depth. Humidity below 85 % is generally considered acceptable for floor coverings. Above this level a host of problems can occur, including mold and mildew, adhesive degradation, plasticizer breakdown, and dimensional changes of flooring such as curling and shrinkage. These forms of distress cause maintenance problems and can lead to trip-and-fall hazards.

A second result from the data was knowledge that the elevated slab was drying while the slab-on-ground was actually becoming wetter, even though the floor was nearly two years old! The data indicated that the concrete slab-on-ground was reaching equilibrium with the wet sand below.

The Figure 5 shows the slab-on-ground was gaining moisture until the end of November

1999 and began to maintain a steady internal RH after that date. By contrast, the elevated slab continued to dry at a fairly constant rate. (The steep rise in the curves seen from 2–6 November is due to the probes reaching equilibrium with the surrounding concrete which takes 3–4 days after placement.)

Figure 5. Results of data collected over two months, related to relative humidity in carpeted concrete floor slabs.

Upon excavation of a portion of the concrete floor, we determined that the granular layer directly below the slab contained 7 % moisture (by weight), sufficient to replace the moisture lost from drying the slab during construction, before flooring was installed. We calculated that the slab-on-ground would take many years to dry sufficiently for moisture-sensitive floor coverings. Therefore, we recom-
